**Report: John Doe 1588**

## **Confidential Inspection Report**

**4432 Lake St NE  
Willmar, MN 56201**

**April 12, 2012**

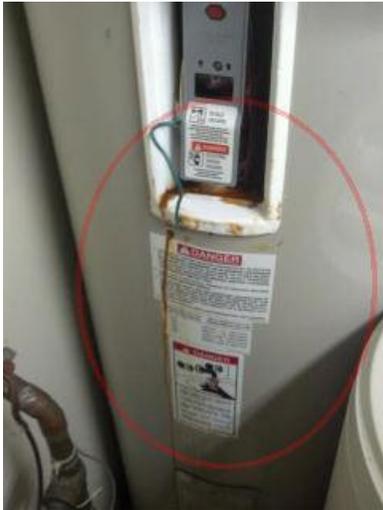
##### Water Heater:

Damage/Defects noted, Leakage has occurred, There is evidence of a leak on the side of the tank. Replacement is indicated. There is a steady flow of water coming from the side of the tank.

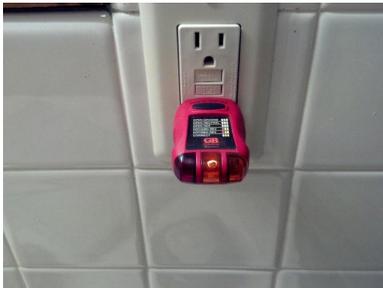
#### *Electrical Outlets:*

Safety Hazard: GFCI not operational, open ground.

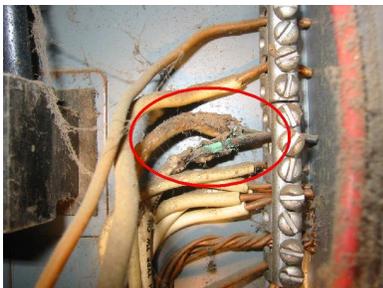
#### *Main Panel Observations:*

Safety Hazard, multiple wires are connected to the same lug and has caused the wires to overheat.

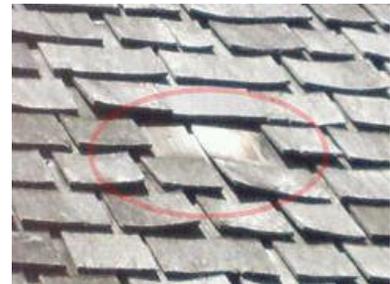
*Roof Covering Condition:* Overall condition is good, however there are 2 shingles missing on the south side of the roof.

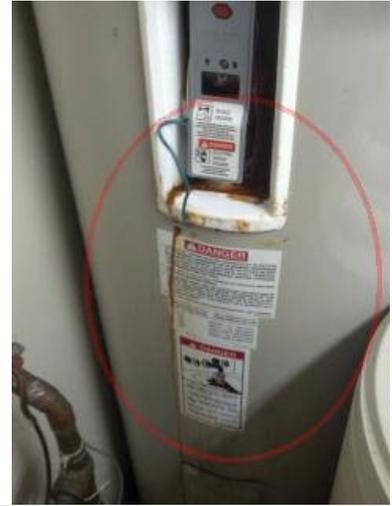
**Water Heater:**

Damage/Defects noted, Leakage has occurred, There is evidence of a leak on the side of the tank. Replacement is indicated. There is a steady flow of water coming from the side of the tank.

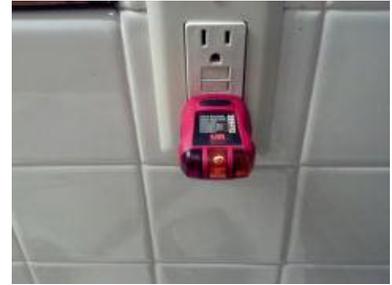
*Electrical Outlets:*

Safety Hazard: GFCI not operational, open ground.

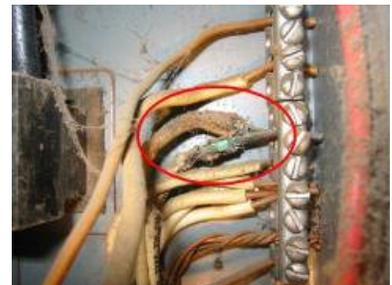
**Electrical Distribution Panels:**

<i>Main Panel Location:</i>	Basement.	
	<i>Main Circuit Rating:</i>	200 amps.	
	<i>Service Disconnect Switch:</i>	Located at the top of main panel.	
<input type="checkbox"/>	<input type="checkbox"/>	<input checked="" type="checkbox"/>	<i>Main Panel Observations:</i> Safety Hazard, multiple wires are connected to the same lug and has caused the wires to overheat.
